HIGH POWER MAGNETOHYDRODYNAMIC SYSTEM. VOLUME II.(U)

AFAPL-TR-78-51-VOL-2

## HIGH POWER MAGNETOHYDRODYNAMIC SYSTEM

TECHNICAL REPORT AFAPL-TR-78-51, Volume II  
Final Report May 1976 - June 1978

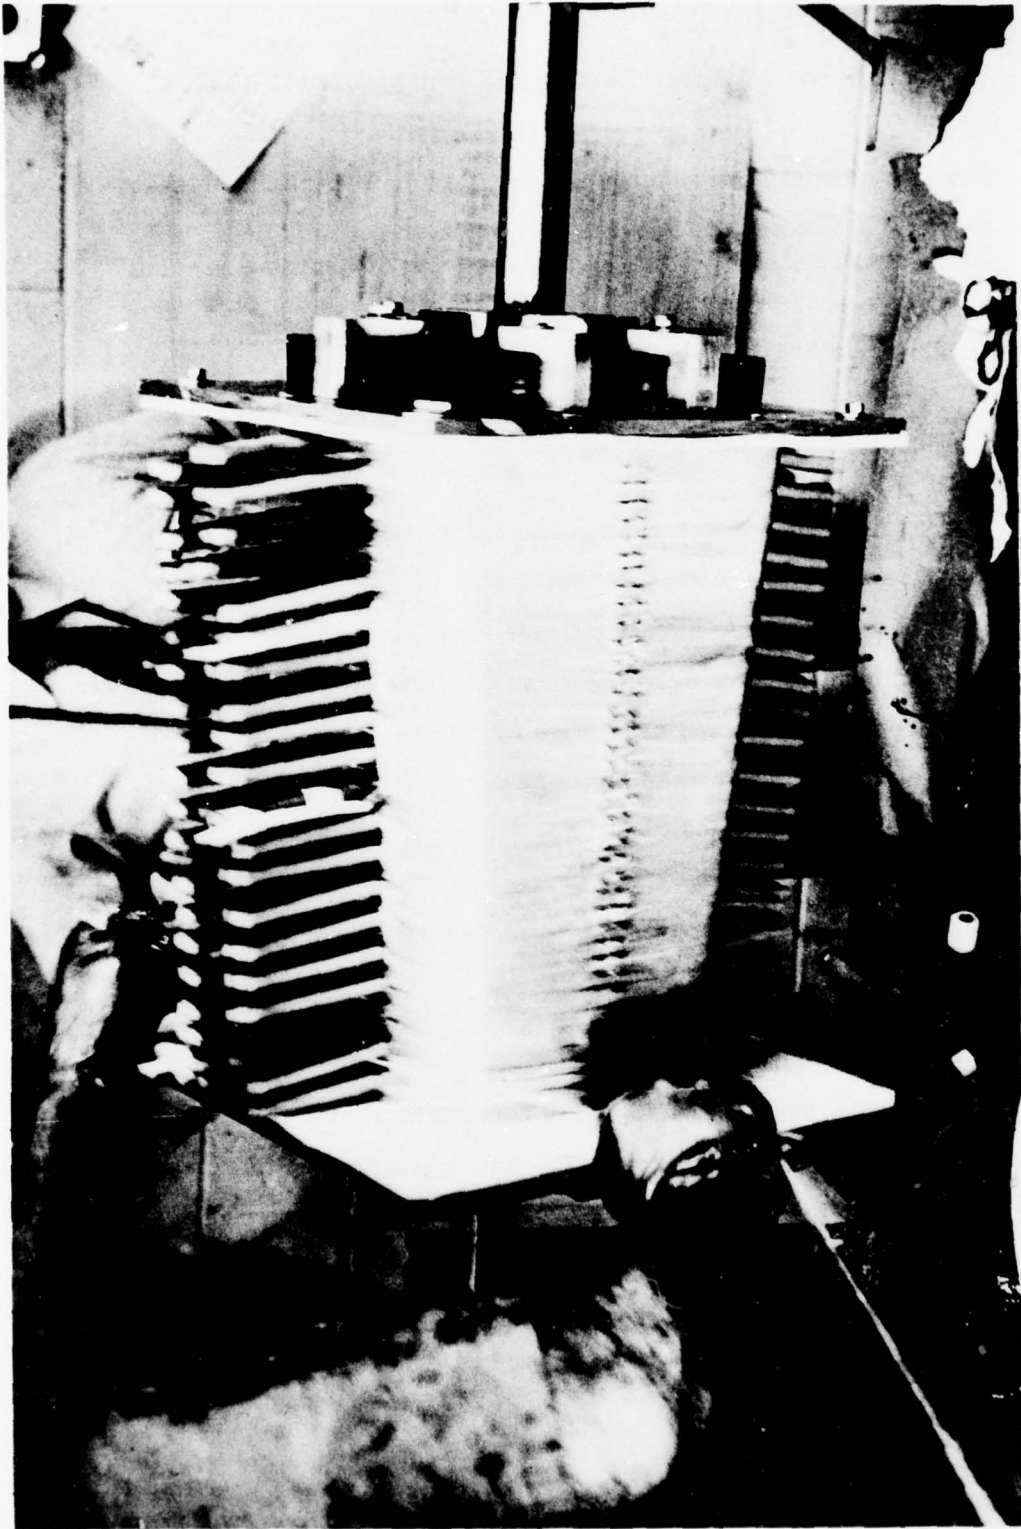
Figure 169. Filament Winding Operation.

Case Cure. To complete the case fabrication, the case was cured in the oven with the mandrel rotating constantly at approximately 7 rpm. The total cure time including warmup was 20 hours at 375 K. The temperatures were monitored throughout this period. Following the cure, the oven was opened and the channel allowed to cool to room temperature. The channel at this stage of fabrication is shown in Figure 172.

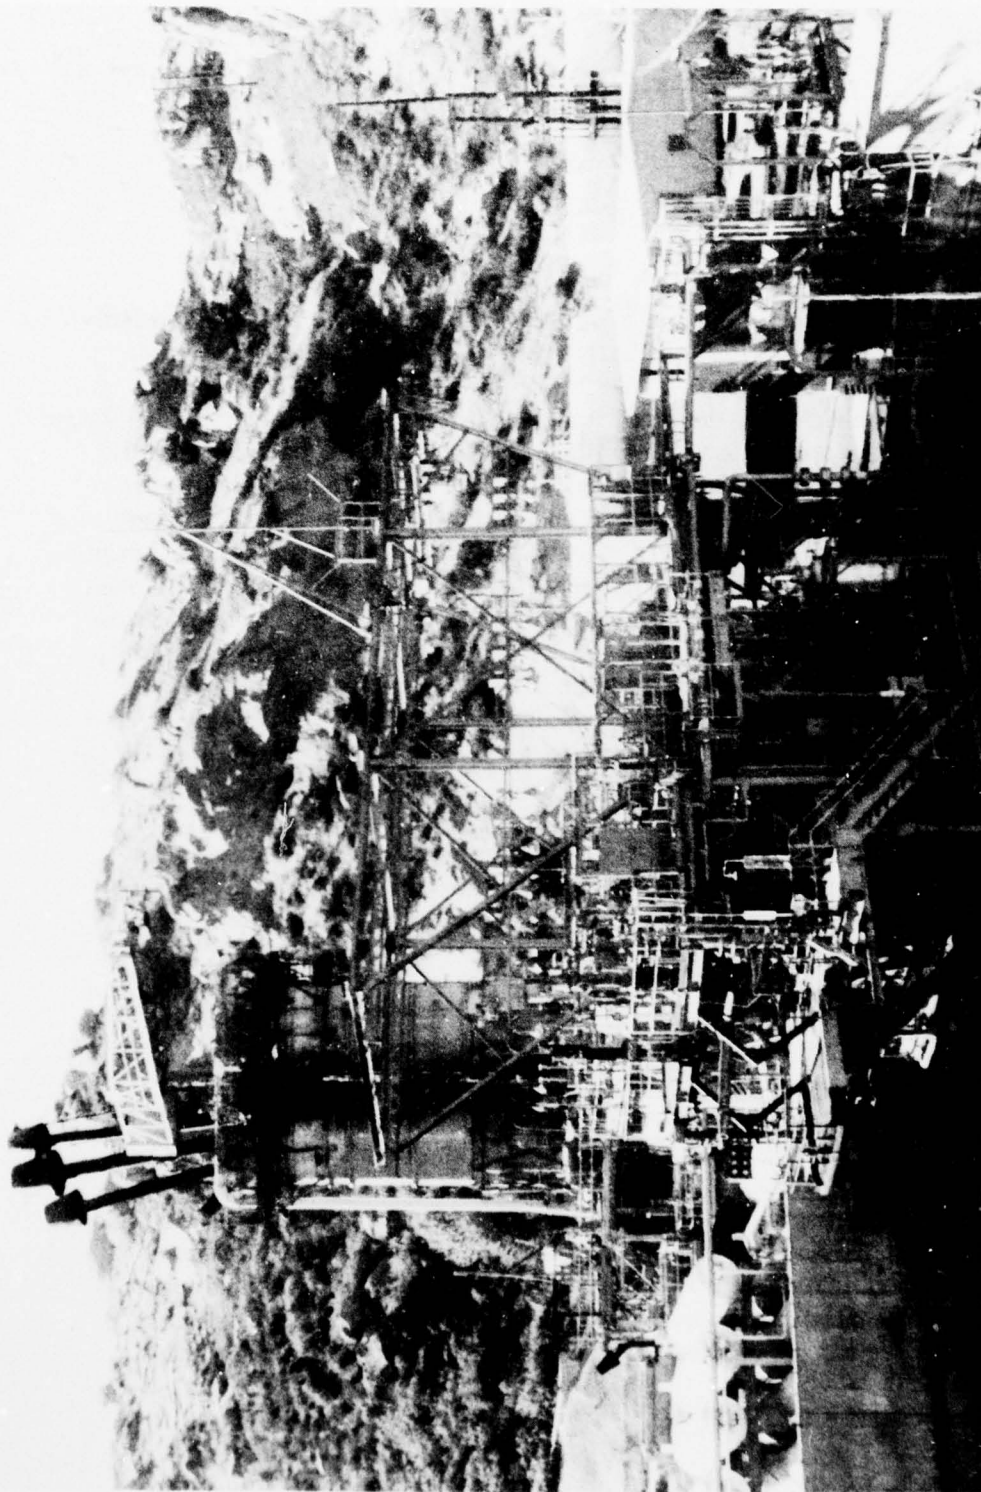
Figure 189. Bravo Test Stand

The gas generator system test program was conducted on test stand Bravo 1, at Rocketdyne's Santa Susana Field Laboratory (SSFL) (Figure 189) during the period from June 1977 through April 1978. The objective of the development test program was to check out, develop, and characterize the gas generator system and to demonstrate the operational capability to produce electrically conducting, hot gas at the design flow rates and temperatures. The gas generator system consisted of the ignition system, injector, seed mixer, and supply system and feed system for the hot gas flow train. A heat sink type development combustor was used in place of the cooled wall combustor. A diagnostics channel was used to determine the gas electrical conductivity and provide MHD channel design information. Facility systems were used for  $\text{LO}_2$ , fuel, purge, ignitor reactant, hydraulic and pneumatic supply. The design of the gas generator system was compatible with the Maxwell Laboratories high power MHD channel design, the Air Force Aero Propulsion Laboratory HPMS magnet at AEDC, and the AEDC test facility.

that described in Sections V and VI. Interfaces with the facility are indicated in Figure 189 and include: (1) fuel supply system; (2) SPAN-80 mixing system; (3) seed tank pressurant supply system; (4) cooling water system; (5) ignitor reactant supply system; (6) liquid oxygen supply system; (7) hydraulic power supply system; and (8) purge supply system. In addition to these items, the facility support systems provided instrumentation and recording, control sequencing, safety circuit monitoring, and electrical power.
